## BUILDING ENGINEERING REPORT (BER)

Building Name: Federal Building – 517 Gold Avenue SW

Location: Albuquerque, New Mexico

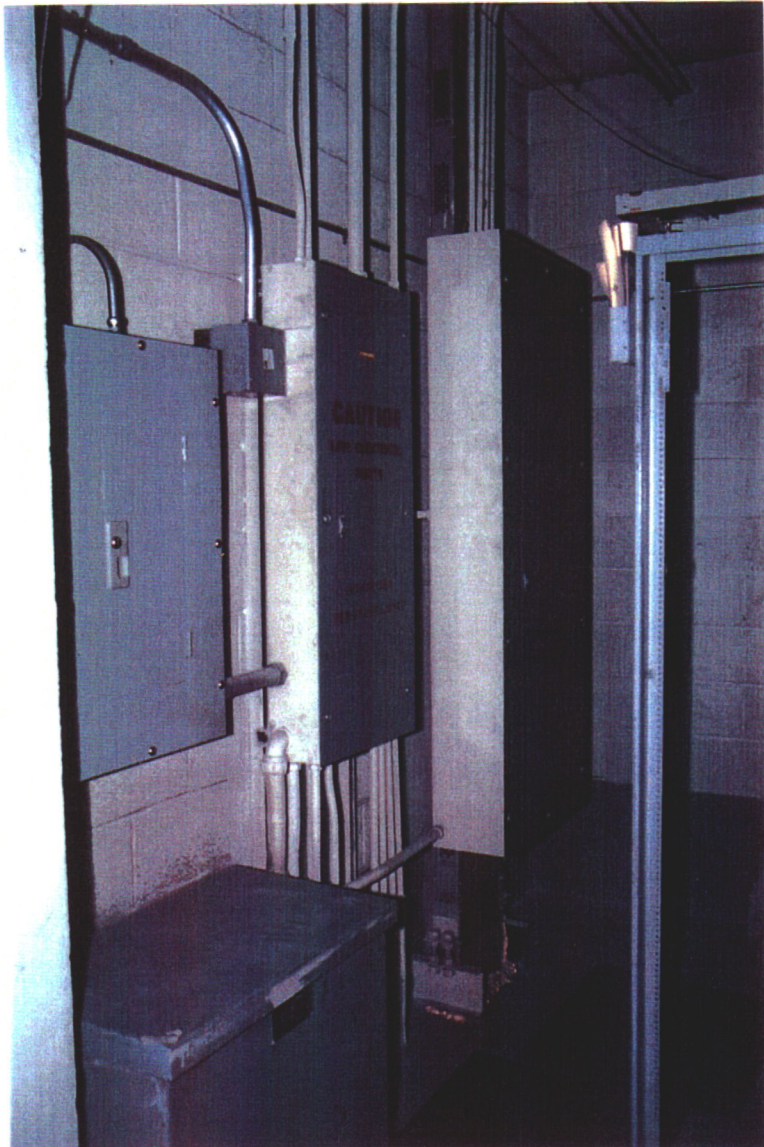
The existing electrical secondary distribution system consisting of the 480/277V bus ducts, 480/277V lighting panelboards, 480-208/120V step-down transformers, and the 208/120V power panels are undersized due to increased load demands, branch circuits added, and type of added loads (i.e. non-linear loads).

The existing Federal Pacific equipment (bus ducts, panelboards, and transformers) is obsolete. Manufacturer support for the Federal Pacific equipment is no longer available.

Working clearances in some of the three electrical/communication rooms located on each of the eight office floors are inadequate to meet the National Electrical Code (NEC).

Existing Electrical Equipment Room (Typical)

It is recommended that the secondary distribution system be upgraded by replacing the existing panelboards and bus ducts, and adding panelboards as necessary. The existing transformers need to be replaced and sized to meet the current and anticipated future load requirements. The new transformers will be k-rated to accommodate existing and future non-linear load requirements.

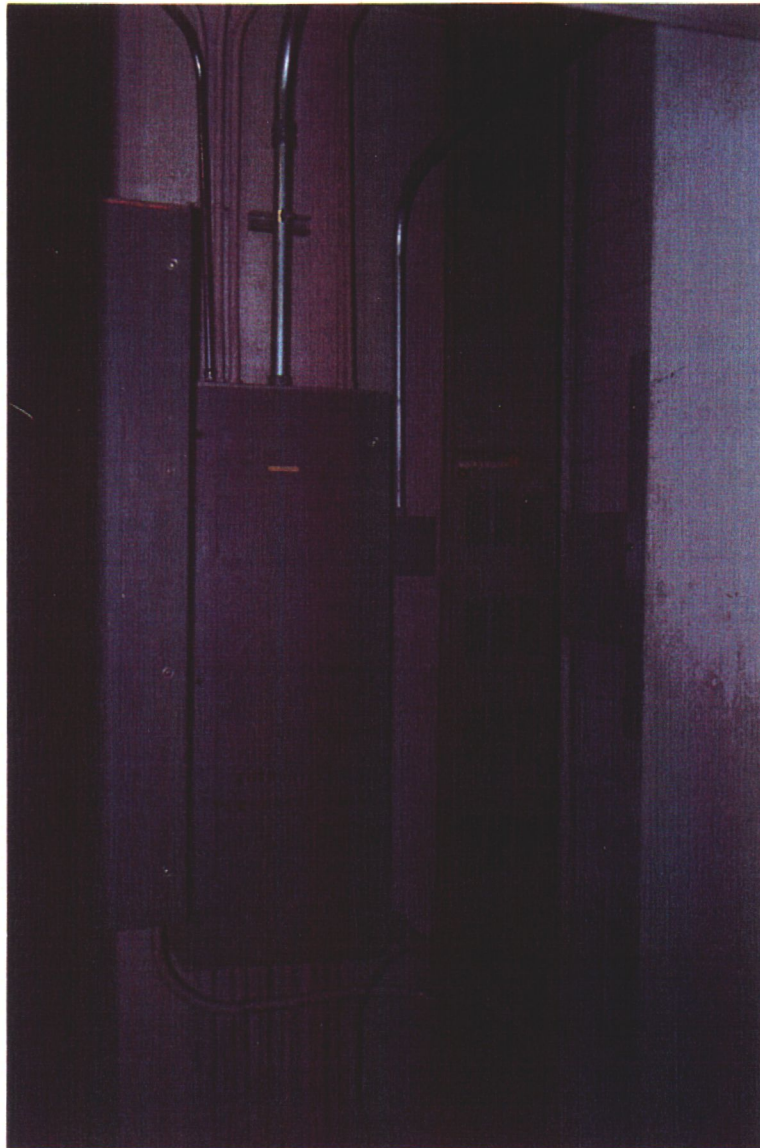
**Existing Electrical Equipment Room (Typical)**
